Manhole Inspection Summary

Manhole # S37I__007MH

Insp Date: **2/12/09 9:35 AM**

Location Address: **601 pratt st**

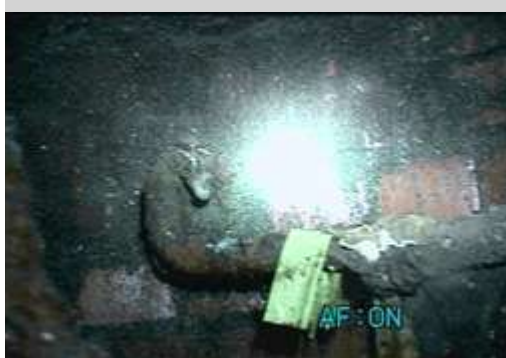
Defect 3

☒ **Evidence Of Surcharge** Depth: **8.** (ft.) ☐ Active Surcharge Present

surcharge evd

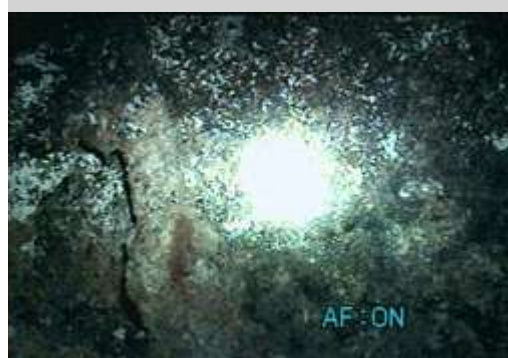
Defect 2

Condition: ☐ Sound ☐ Cracked ☐ Root Intrusion ☐ Deteriorated ☐ Leaks ☒ **Debris**

bench debris

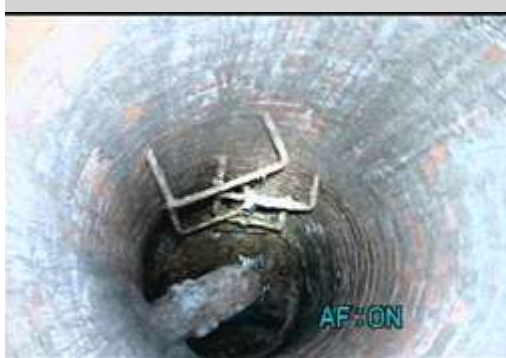
Defect 1

Count: **6** Missing: **0** ☒ **Corroded**

corr steps

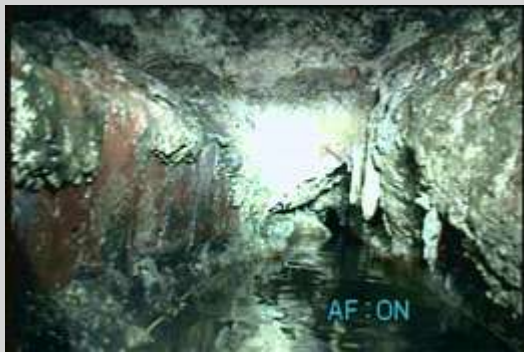
12 O'Clock Outflow

Invert Depth: **13.29** (ft.) Flow Characteristics: **Slow**

Deposits: ☒ None ☐ Mud ☐ Sludge ☐ Debris ☐ Grease

Infiltration: **None** Pipe Seal Cond: **Unknown**

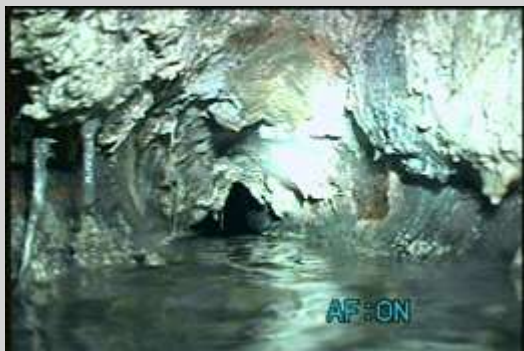
5 O'Clock Inflow

Invert Depth: **5.58** (ft.) Flow Characteristics: **Slow**

Deposits: ☒ None ☐ Mud ☐ Sludge ☐ Debris ☐ Grease

Infiltration: **None** Pipe Seal Cond: **Unknown**

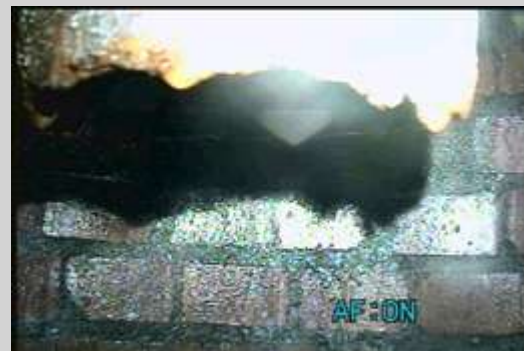
Drop In @ 5 O'Clock

Drop: **Inside** **Direct**

Inv Depth: **13.16** (ft.)

Drop Condition: **Open**
